| CITY OF BALTIMORE WET W SMOKE AND DYED W | Page 1 of 4 | |
| Manhole ID: S37MM_012MH | Test ID: 0994-344 | Notifications Made:_X (Residents, Fire, 311) |

CITY OF BALTIMORE SMOKE TESTING OBSERVATION SUMMARY JONES FALLS SEWERSHED

BALTIMORE CITY PROJECT 994 REI/DRAYCO

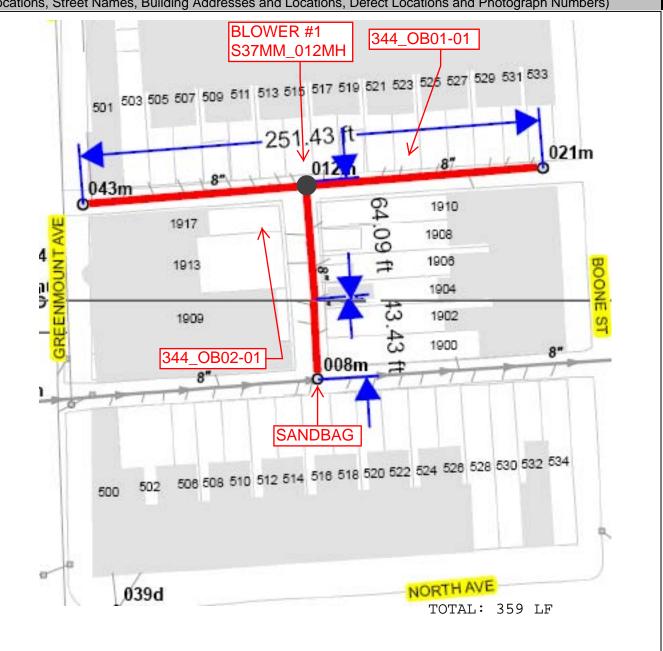
Field Sketch: (Show All Manholes with Numbers, Blower Placement Location, Sandbag or Isolation Locations, Street Names, Building Addresses and Locations, Defect Locations and Photograph Numbers)

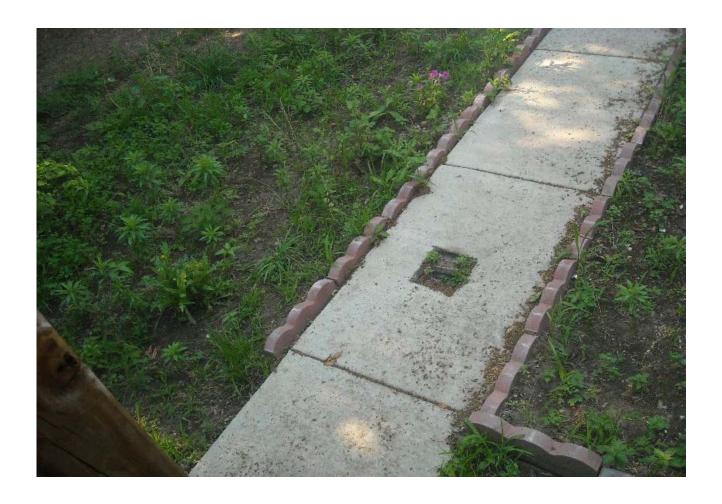
Photograph No: OB01-01 Filename: 0994-344_OB01-01.jpg

Defect No: 1 Supervisor: E.R. Dye Test Recommended: N

House No: 523 Street Name: E. 22ND Street Type: ST. Source Type: 03 Location: 01 Severity: 02

Comments: CLEAN OUT - ABOVE GRADE. BROKEN CAP.

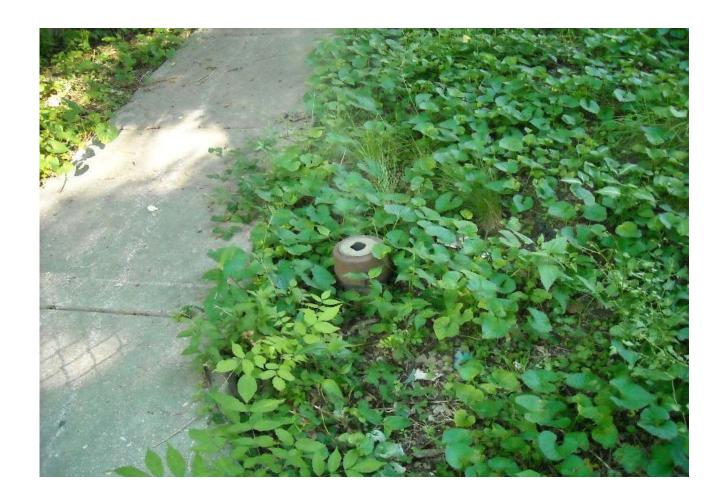
Photograph No: OB02-01 Filename: 0994-344_OB02-01.jpg

| Unique Test ID: 344 | Date: 06/13/2008 | Basin: JF-19 |
|---|---|---|
| Defect No: 2 | Supervisor: E.R. | Dye Test Recommended: N |
| House No: 1917 | Street Name: GREENMOUNT | Street Type: AVE |
| Source Type: 03 | Location: 08 | Severity: 02 |

Comments: CLEAN OUT - ABOVE GRADE. BROKEN CAP.
